## Preventive Maintenance for FEPP 6x6 Suspension Torque Rods

*Roscommon Equipment Center*  
 Northeast Forest Fire Supervisors  
*in Cooperation with*  
 Michigan's Forest Fire Experiment Station

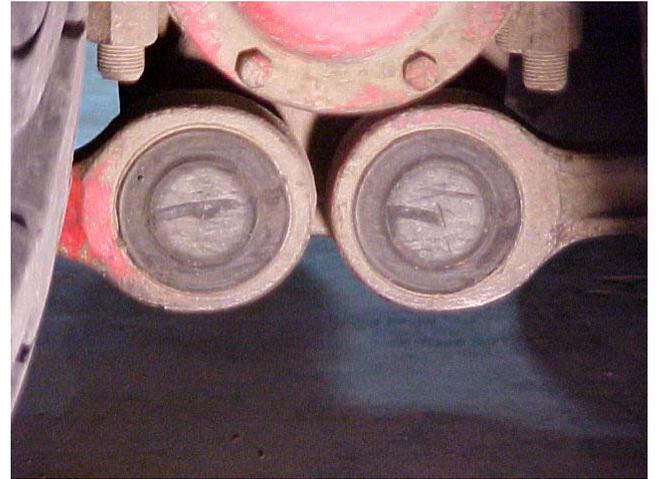
**Figure 6.** These rod ends have been in service for five to six years. The rubber is still in excellent condition.

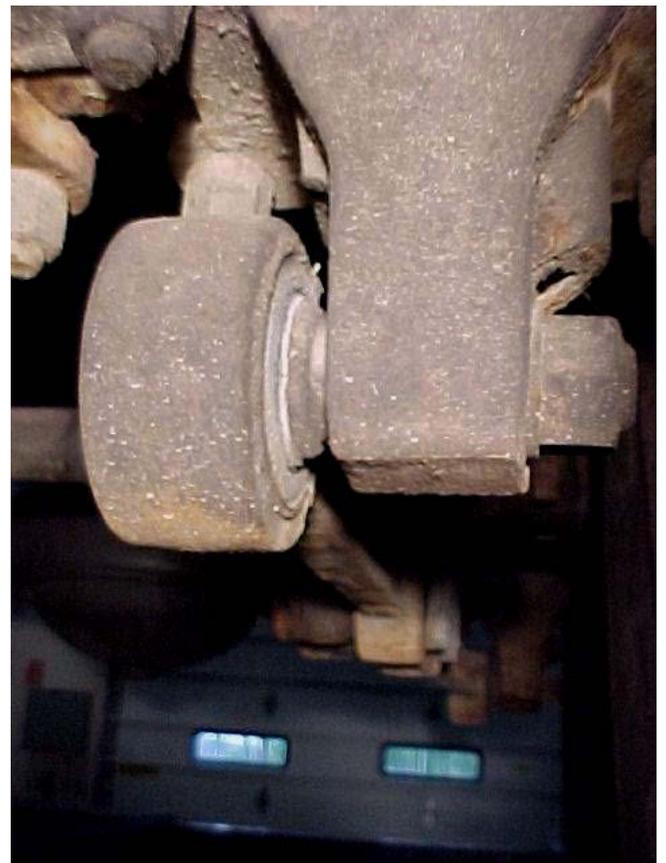
**Figure 7.** When you inspect the rod ends, always check both the outer and inner sides of them. The rubber of this rod end shows signs of weathering, but no separation from the metal sleeve or ball joint.

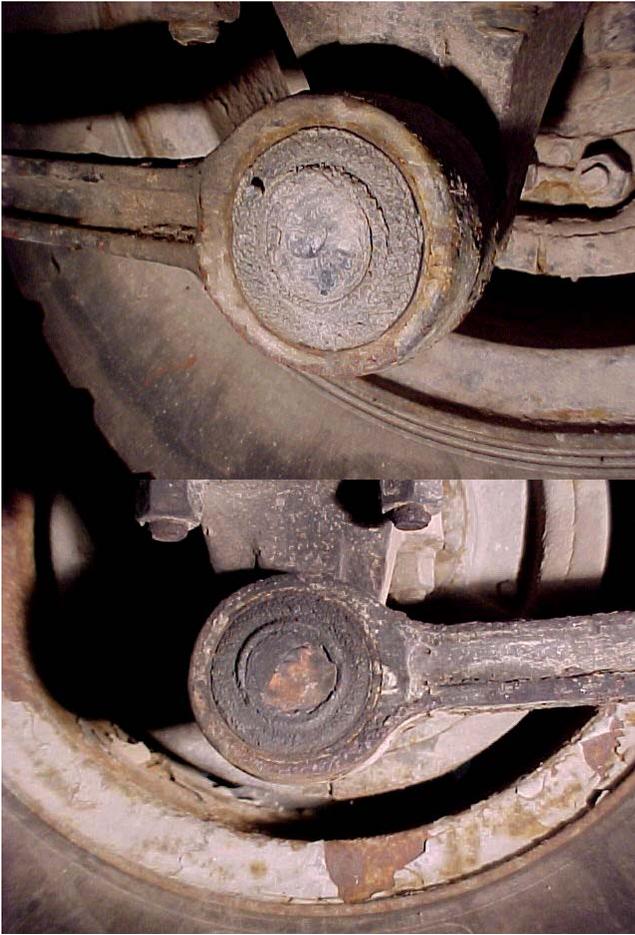
**Figure 8.** The above photos show rod ends that are starting to show some signs of deterioration. However, they would still be considered to be in usable condition. Notice the rubber peeling off the end of the inner ball joint. This is not an indication of a major problem.

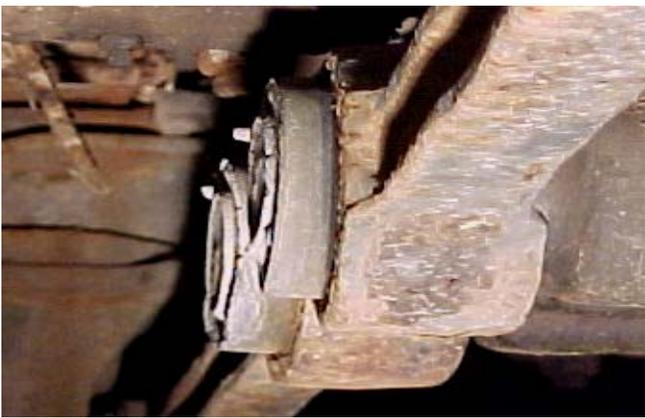
**Figure 9.** The outer metal sleeve has completely separated from the rubber on both of the above rod ends, allowing the torque rods to slide against the frame.

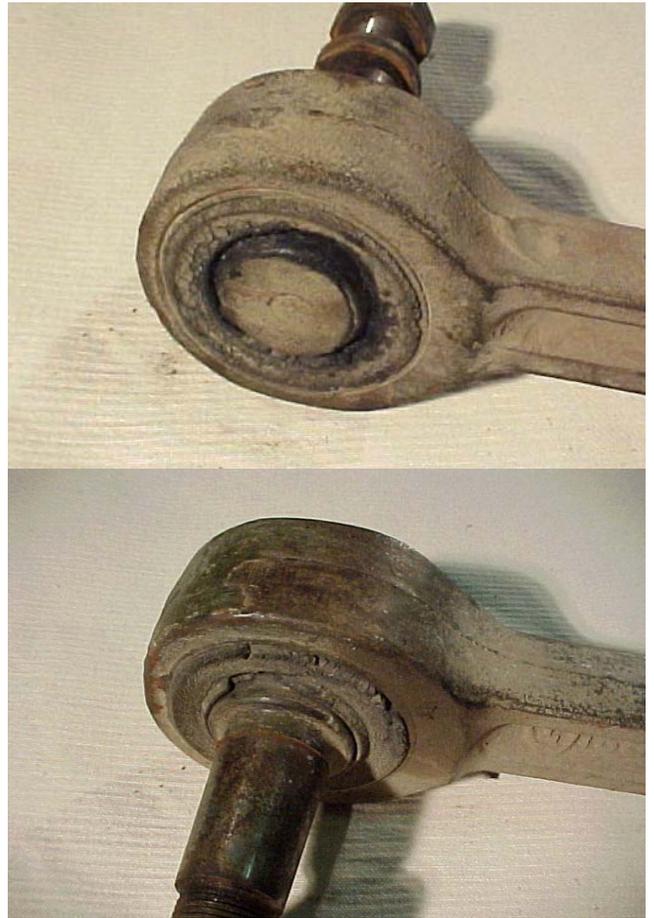
**Figure 10.** The rubber on the above rod end is beginning to separate from the ball joint. These rod ends should be replaced.

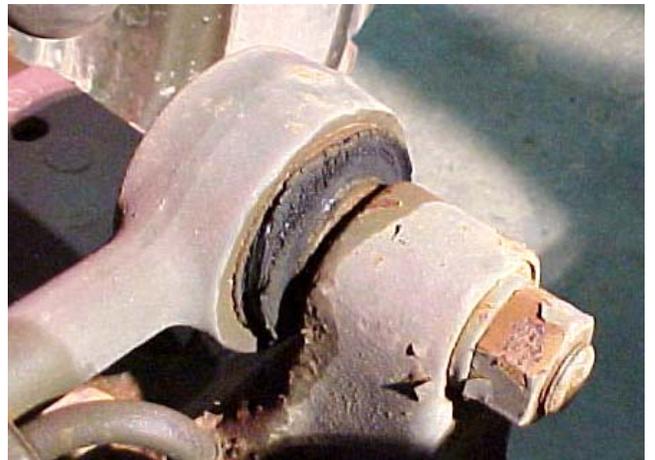
**Figure 11.** This is an example of the rubber separating from the outer metal sleeve of the ball joint. This rod end should be replaced.

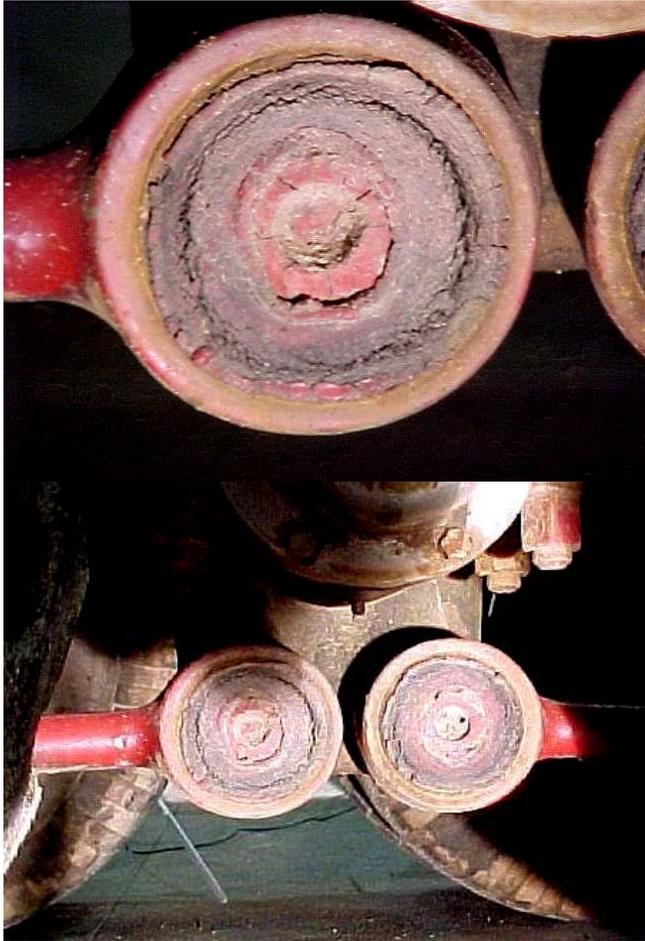
**Figure 12.** The rubber itself may also fail. As the rubber deteriorates, the rotational forces can shear the rubber between the metal sleeve and the ball joint as shown above.
