## Preventive Maintenance for FEPP 6x6 Suspension Torque Rods

*Roscommon Equipment Center*  
 Northeast Forest Fire Supervisors  
*in Cooperation with*  
 Michigan's Forest Fire Experiment Station

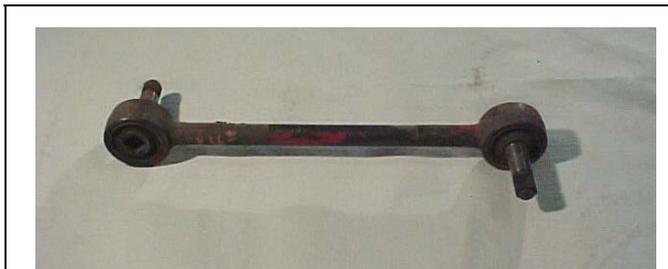
**Figure 1.** The torque rod assemblies for 2-1/2 and 5 ton 6x6's are very similar. Some of the rods are round from eye to eye (as above) and on some, the shaft between the eyes has an "I-beam" cross section.

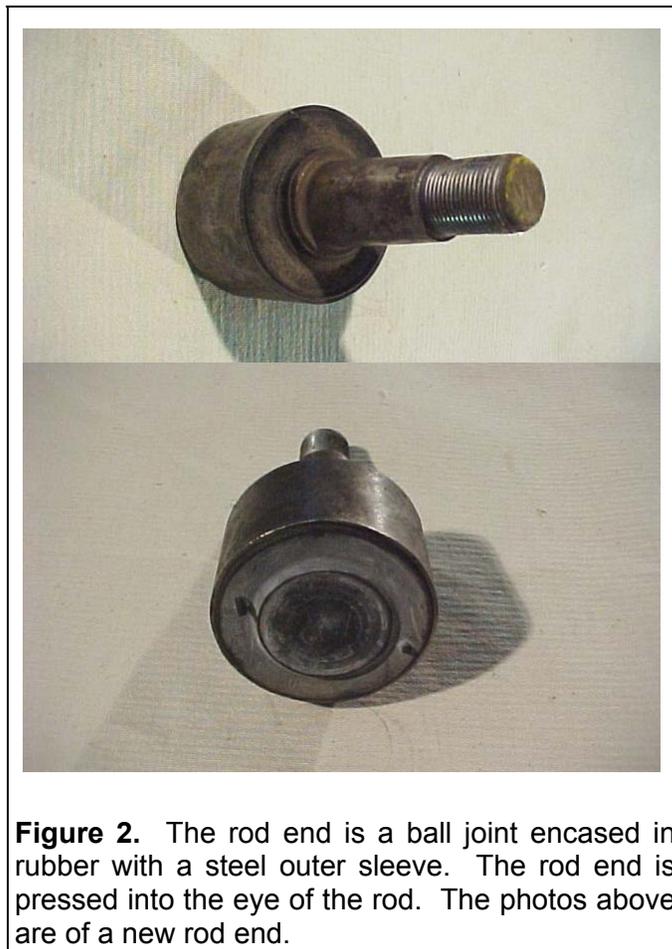
**Figure 2.** The rod end is a ball joint encased in rubber with a steel outer sleeve. The rod end is pressed into the eye of the rod. The photos above are of a new rod end.

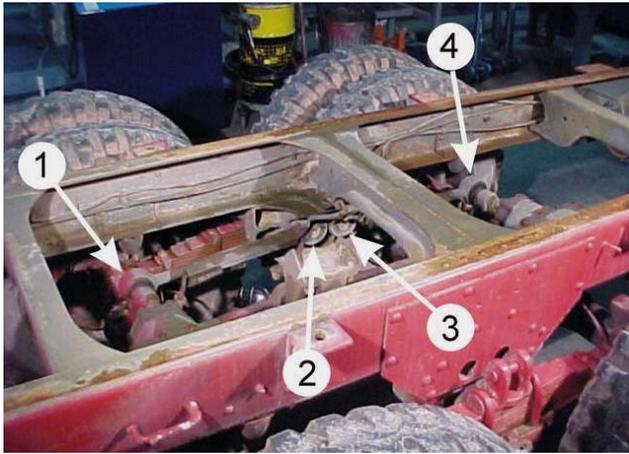
**Figure 3.** The two upper torque rod assemblies (four rod ends) may be inspected from below the unit. However, for photographic purposes, the water tank was removed from this unit.

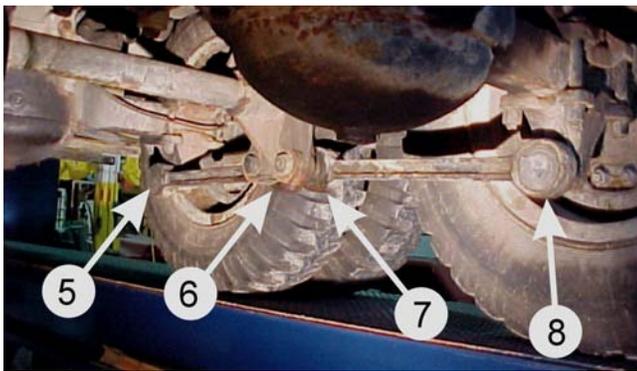
**Figure 4.** Two lower torque rod assemblies are located on each side of the vehicle. Four rod ends on each side should be inspected.

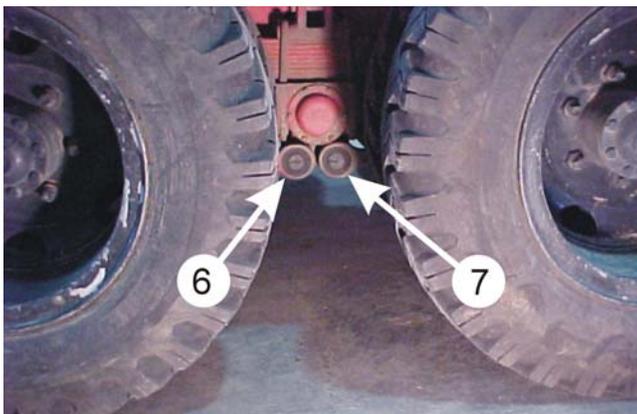
**Figure 5.** The center two lower rod ends may be easily seen by standing next to the unit and looking between the rear duals.
